Premature Metal Roof Deck Corrosion: Difficult to Detect and Diagnose

By: Mark H. Hopmann, PE; Principal at WJE
and Kimberly Steiner, Senior Associate at WJE

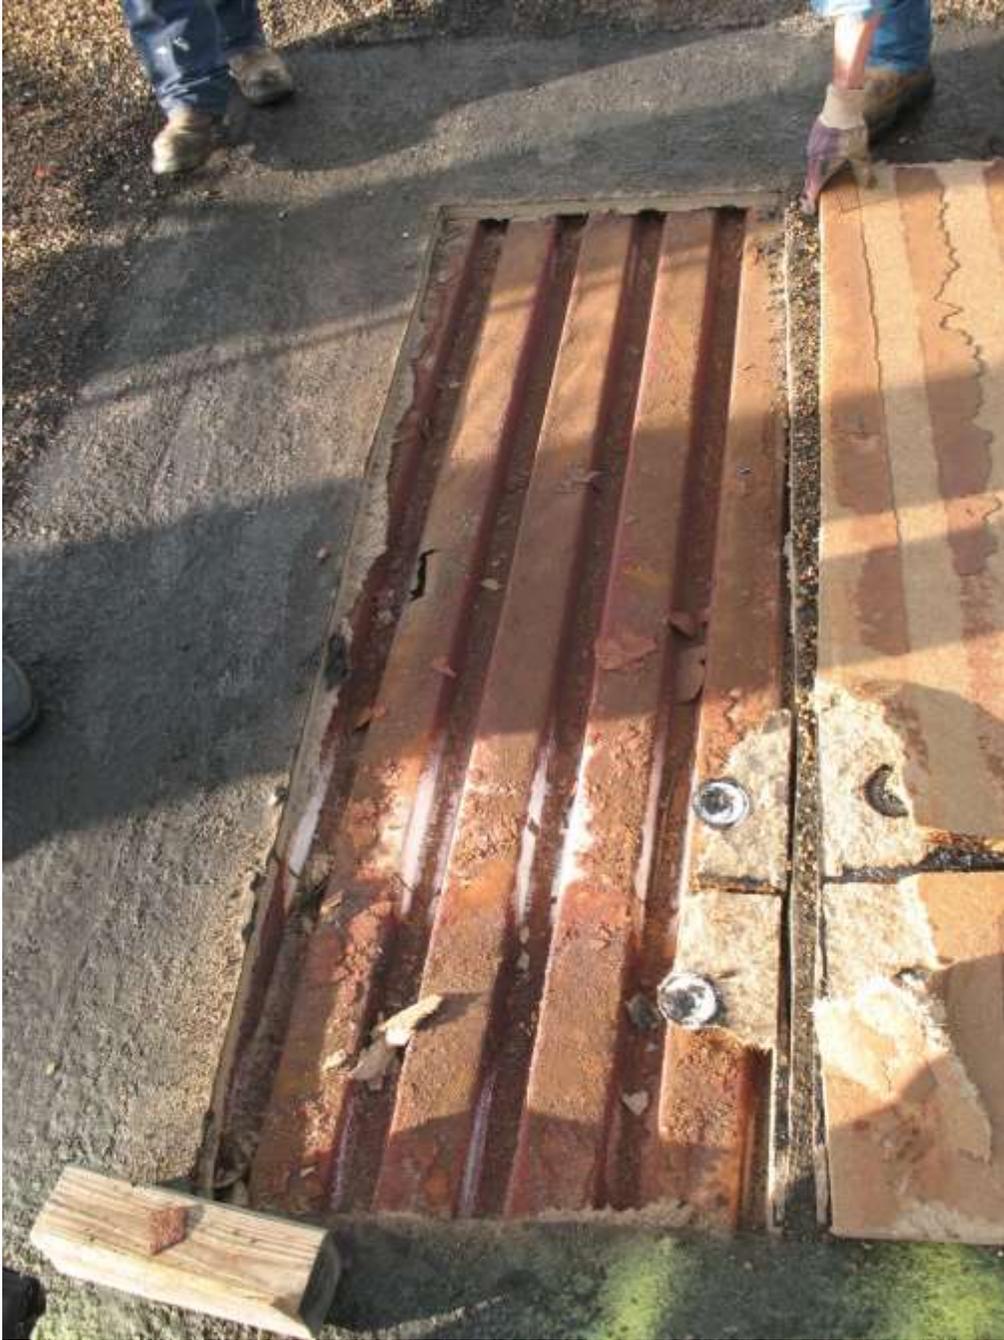
Figure 1:

Comment [o81]: Are both pictures from the same cut?

Comment [o82]: It is curious how red the steel deck is. Red rust occurs on bare steel. Rust on galvanized deck is white.
